## RESIDENTIAL HOME INSPECTION REPORT

1234 Main Street  
Fernandina Beach, FL 32034

Buyer Name  
10/13/2025 9:00AM

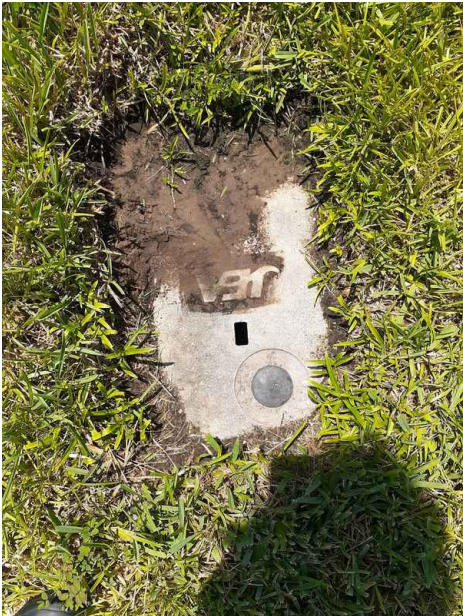
**Water Supply and Distribution:**  
**Water meter location**  
underground box near the street

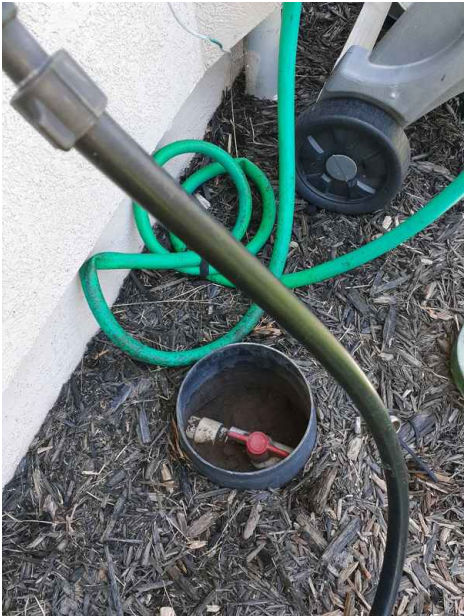
**Water Supply and Distribution:**  
**Main water shut-off: location**  
underground box next to home, East Side

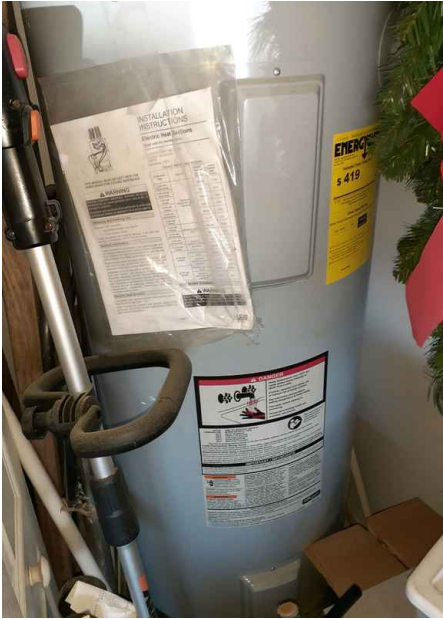
**Water Heater: Photo of water heater**

The photo shows the data plate of the water heater.

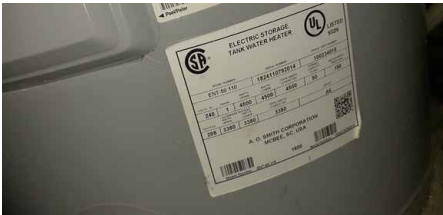
**Water Heater: Data plate: photo**

The photo shows the data plate of this water heater.

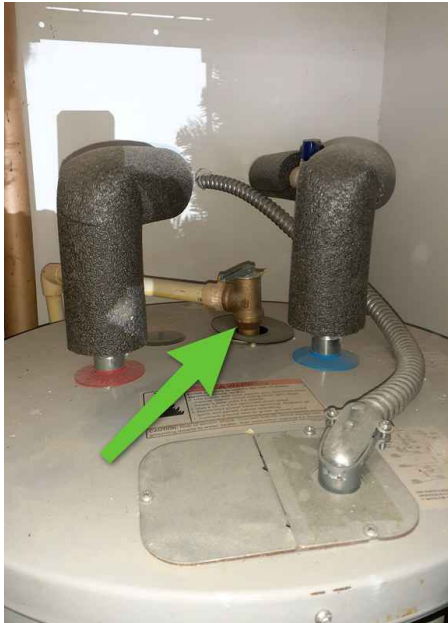
### Water Heater: TPR valve: present

The water heater was equipped with a temperature/pressure relief (TPR) valve that was not operated by the Inspector. Operating the TPR valve lies beyond the scope of the General Home Inspection. The Inspector recommends that the TPR be operated by the homeowner monthly as a maintenance measure.

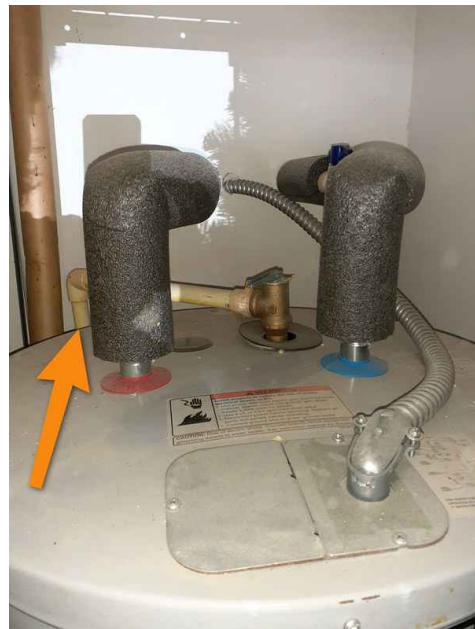
The termination point of the discharge pipe for the water heater temperature/pressure relief (TPR) valve was not readily observable. The termination should be visible to help ensure that the termination is never capped. This condition should be corrected by a qualified plumbing contractor.

## Recommendation

Contact a qualified plumbing contractor.

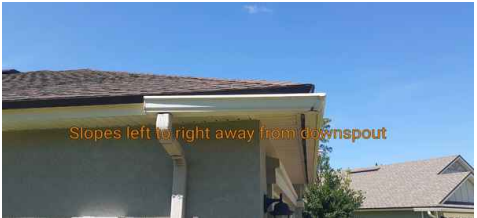
GUTTERS: SLOPE, IMPROPER

Some gutters sloped incorrectly. This condition can result in water pooling in the gutters, encouraging corrosion and shortening gutter lifespan. It can also allow spillage that can cause foundation/structural damage related to soil movement. Gutters should be brought into good working order by a qualified contractor.

Recommendation

Contact a qualified professional.

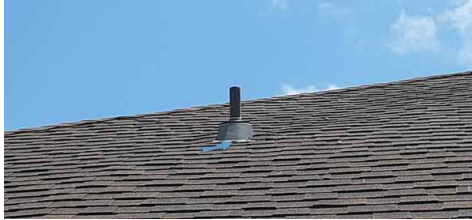
**PLUMBING VENT: FLASHING, EXPOSED FASTENERS**

On the roof, plumbing stack vent flashing fasteners were exposed. This condition increases the potential for damage from roof leakage. Recommend homeowner monitor and have sealed as needed.

Recommendation

Contact a handyman or DIY project

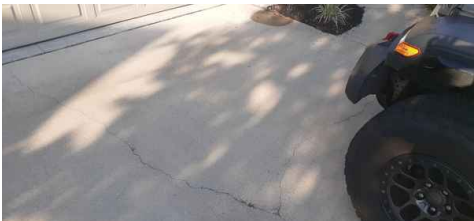
**CRACKS: SHRINKAGE**

The concrete driveway had shrinkage cracks that commonly occur as newly-placed concrete dries. They are surface cracks that are not a structural concern.

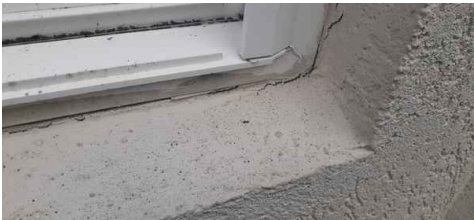
**WINDOWS: SEALANT CRACKING - MINOR**

Windows sealant was observed to have minor cracking. Recommend monitoring and repair/replacement of sealant if the cracks worsen.

Recommendation

Contact a handyman or DIY project

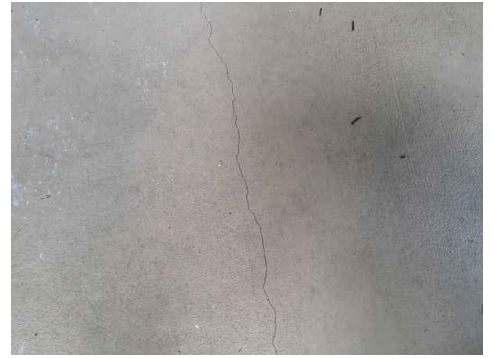
**CONCRETE SLAB: COMMON CRACKS LESS THAN 1/4 IN.**

The concrete porch slab had common cracks (1/4-inch (6.3mm) or less). Recommend monitoring for additional movement.

Recommendation

Recommended DIY Project

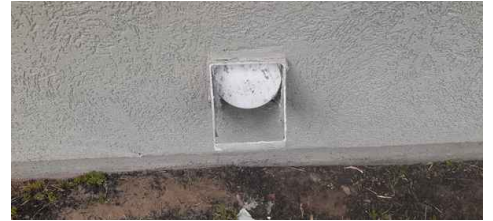
### **DRYER EXHAUST DUCT: DISCHARGE COVER MISSING/DAMAGED**

Where it discharged to the home exterior, the dryer exhaust duct was missing or damaged. A proper cover should be installed by a qualified contractor.

Recommendation

Contact a qualified professional.

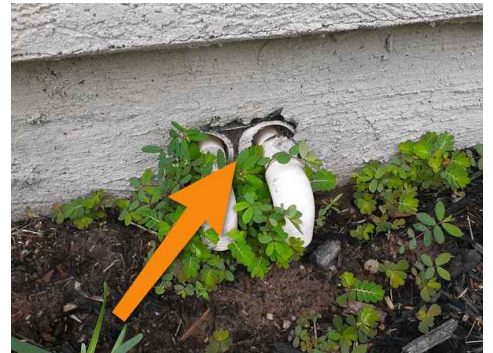
Pipes penetrating exterior walls left gaps that needed to be sealed with an appropriate sealant to prevent moisture and insect entry.

Recommendation

Contact a handyman or DIY project

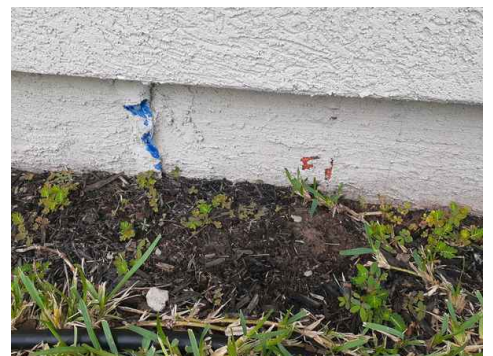
### **PARGE COAT: DETERIORATION MINOR**

A parge coat covered the foundation exterior surface. Parge coats are layers of mortar-like material applied with a trowel and designed to harden, cover and protect the exterior surface of the foundation wall.

Recommendation

Contact a qualified professional.

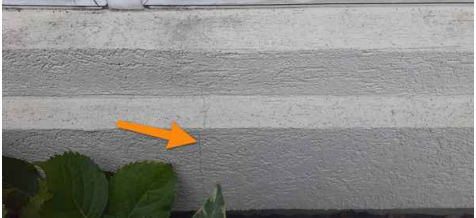
**CRACKING: MINOR**

AT BASE OF FRONT BEDROOM WINDOW

Stucco exterior showed signs of minor cracking in one or more areas. Identifying the cause and/or determining the level of risk of continuing damage associated with this condition exceeds the scope of the General Home Inspection. Recommend monitoring and repair if cracks expand.

Recommendation

Contact a stucco repair contractor

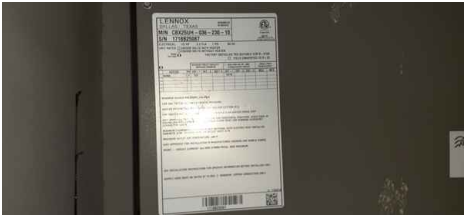
| <b>Heating: Air filter type</b><br>Pleated, Fiberglass/synthetic | <b>Heating: Annual Fuel Utilization Efficiency (AFUE) Rating</b><br>High (90%-98%) | <b>Heating: Data plate: photo</b><br>The photo shows the furnace data pate or manufacturer's label |

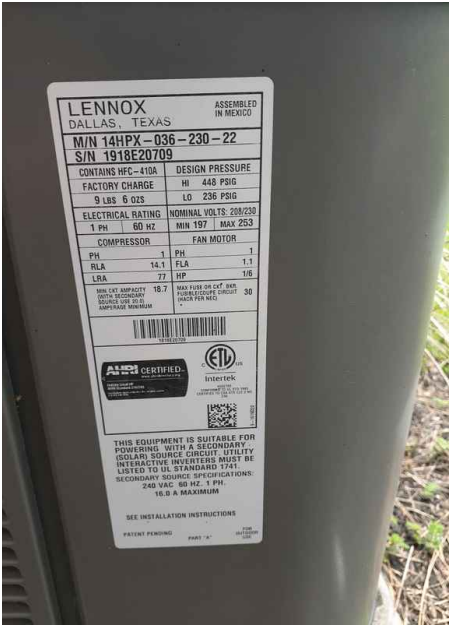
Cooling: Condenser: data plate, photo

Information from the air-conditioner compressor unit data plate is shown in the photo.

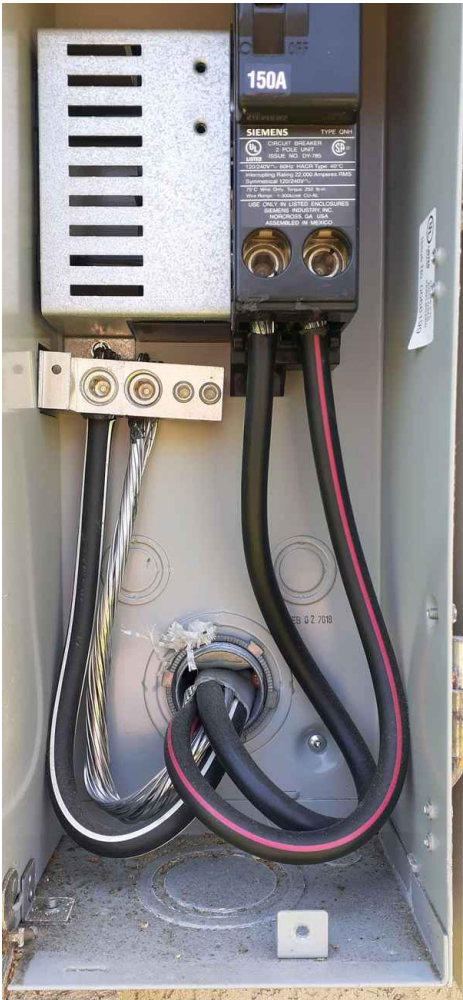
| <b>Electric Meter: Electric meter type</b><br>Electromechanical (conventional) | <b>Service Entrance Cables: Service entrance cables: materials and ampacity</b><br>2/0 aluminum/150 amps | <b>Service Entrance Cables: Viewed service entrance conductors at:</b><br>In the service panel |

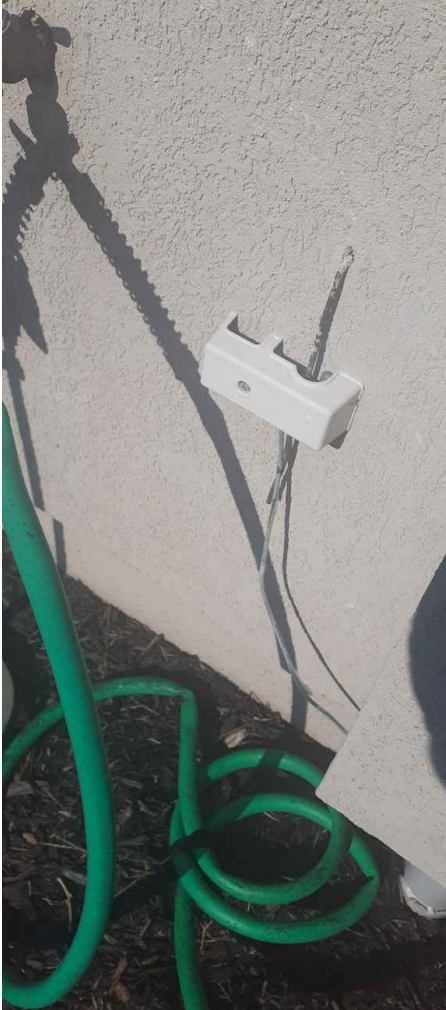
**Service Grounding and Bonding: Grounding electrode system: driven rod**

The service panel had a grounding electrode conductor (GEC) visible that was bonded to the service panel and that was properly clamped to the top of a driven rod that serves as the grounding electrode. Driven rods are typically an 8-foot copper or steel rod required to be driven into the soil for its full length. The inspector was unable to confirm the length of the driven rod. Evaluation of the effectiveness of the service ground would require the services of a qualified electrical contractor using special instruments.

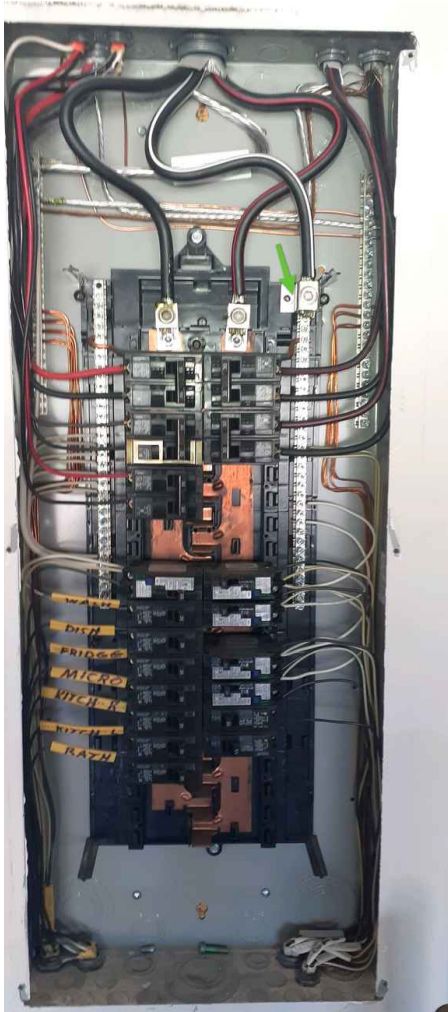
### Sub-Panel Grounding & Bonding: Neutral & grounds isolated

The neutral and grounding conductors were electrically isolated from each other in this sub-panel. This is a proper condition.

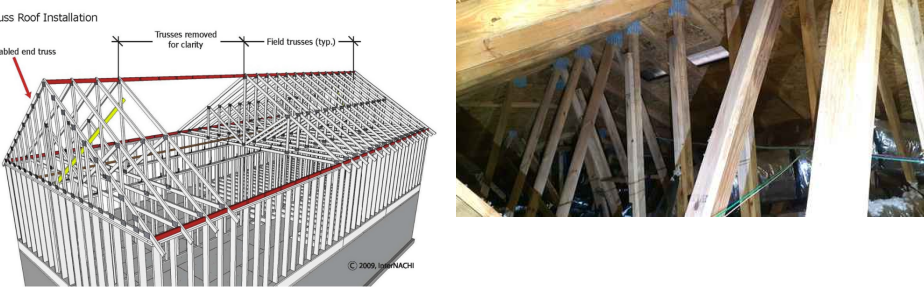
**Roof Trusses:** Truss roof

The roof was framed using manufactured roof trusses. Roof trusses should never be cut or structurally altered in any way. Using the truss interior attic area for storage may place improper structural loads on parts of the trusses not designed to support those loads and should be avoided.
